# A TECHNOLOGICAL SURVEY OF VISION BLOCK MATERIALS AND DESIGN

DETROIT ORDNANCE DISTRICT
CONTRACT No. DA-20-018-ORD-23389
DEPARTMENT OF THE ARMY
OMS 5510.12.25500.13
OMS 5510.12.24100.03

## AEROFAB COMPANY, INC.

OCTOBER, 1962

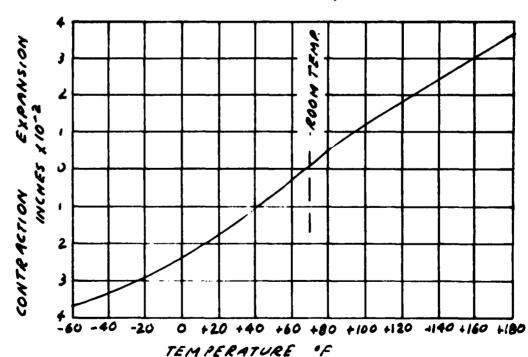
(EXHIBIT A)

The most apparent characteristic that this bond must have is the ability to compensate or distribute the strain resulting from the differential expansion of glass and plastic. See exhibit A. Of necessity this interlayer must therefore be elastomeric.

TEMPERATURE °F DIFFERENTIAL ELONGATION OF PLASTIC & GLASS THROUGHOUT AMBIENT TEMPERATURE RANGE
